Archaeological Investigation of the Laundry Aiken-Rhett House, Charleston, SC

Archaeological Contributions 49

Prepared for Historic Charleston Foundation
December 2016

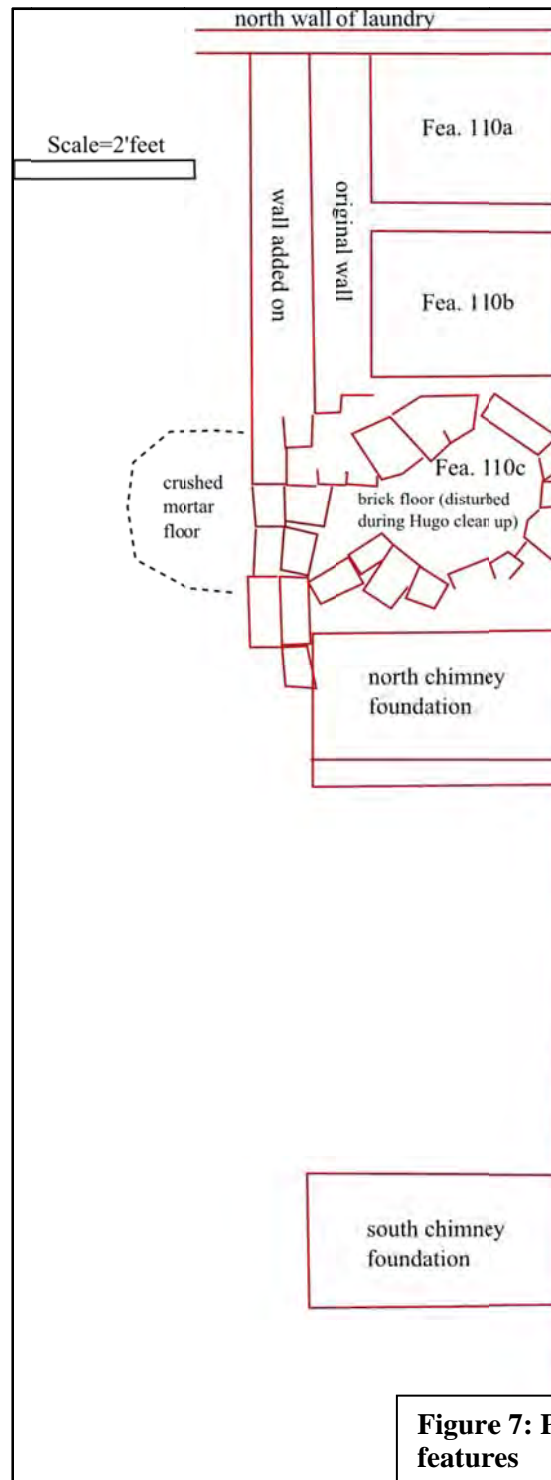
Figure 7: Plan view of all identified brick features

outlined by brick. This cell is called Feature 110. It is separated in the middle by a one-course wide row of brick that appeared to be an intact foundation held together with mortar. This central brick line splits the cell into two squares; the north half is Feature 110a and the south half is Feature 110b. South of 110b is a circular brick feature that is called Feature 110c. Feature 110c was the brick feature documented by Martha Zierden during the Hurricane Hugo mitigation.

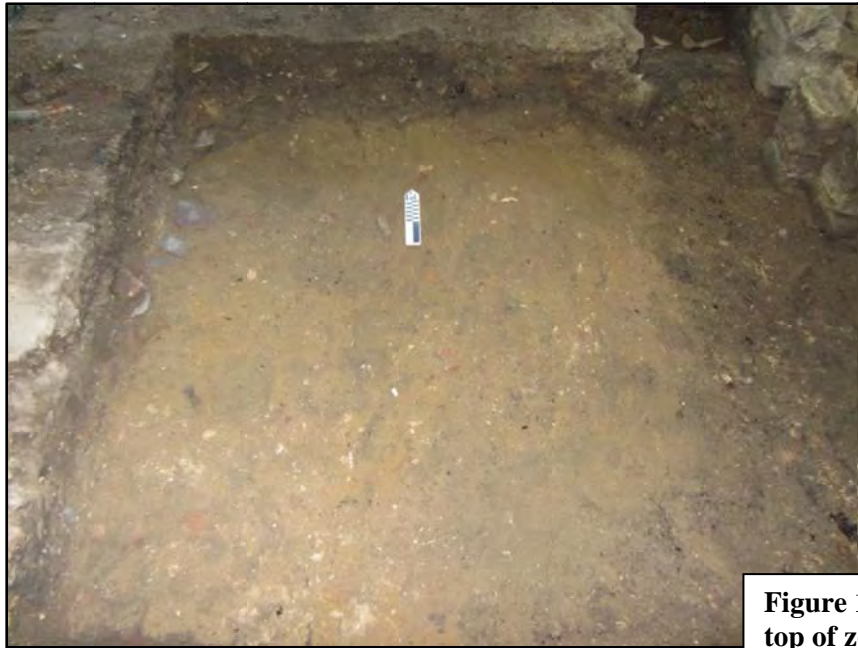
Figure 11: Photo, plan view of the top of zone 5 in Unit 6

We interpret Zone 7 as being a mass of features that could only be understood if a much larger space was excavated. The Zone 6 soil appears to have been laid down by Robinson, the previous owner and improver of the lot before the Aiken's lived there. It is unknown if the Aikens or Robinson built the clay floor. It seems that all of the fill in this part of yard, which is consistent with Zierden's findings along the eastern brick wall that retains the Aiken yard, was used to reclaim the marshland associated with a creek that once passed by the current Aiken yard. It is also very possible that other soils in the spaces outside of the laundry relate to the pre-Aiken period.

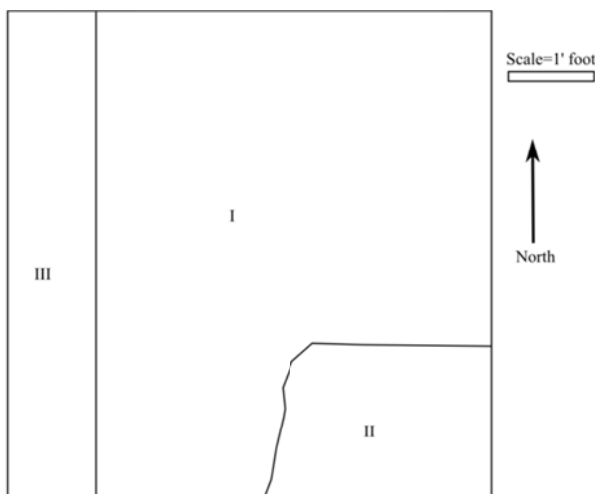
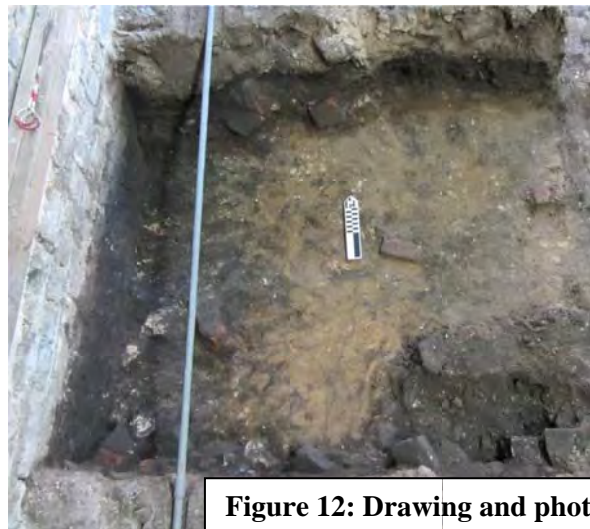
Figure 12: Drawing and photo, top of zone 5 in Unit 7

- I. 10YR5/4 yellowish brown sandy clay - Zone 5
- II. 10YR3/1 very dark gray loose sand with rubble - potential feature
- III. 10YR2/1 black sandy loam with rubble and mortar - builder's trench

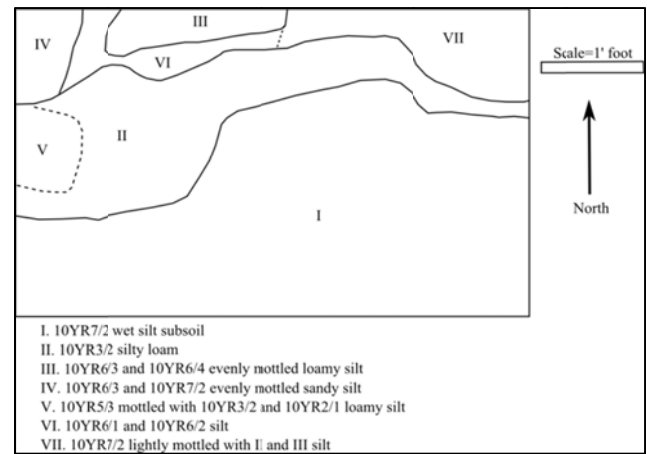
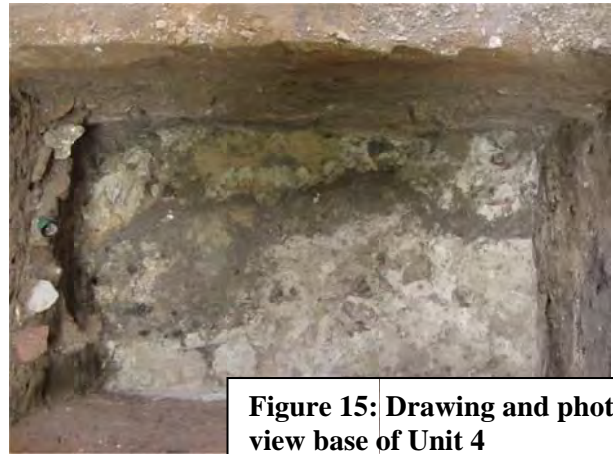
Figure 15: Drawing and photo, plan view base of Unit 4

- I. 10YR7/2 wet silt subsoil
- II. 10YR3/2 silty loam
- III. 10YR6/3 and 10YR6/4 evenly mottled loamy silt
- IV. 10YR6/3 and 10YR7/2 evenly mottled sandy silt
- V. 10YR5/3 mottled with 10YR3/2 and 10YR2/1 loamy silt
- VI. 10YR6/1 and 10YR6/2 silt
- VII. 10YR7/2 lightly mottled with I and III silt

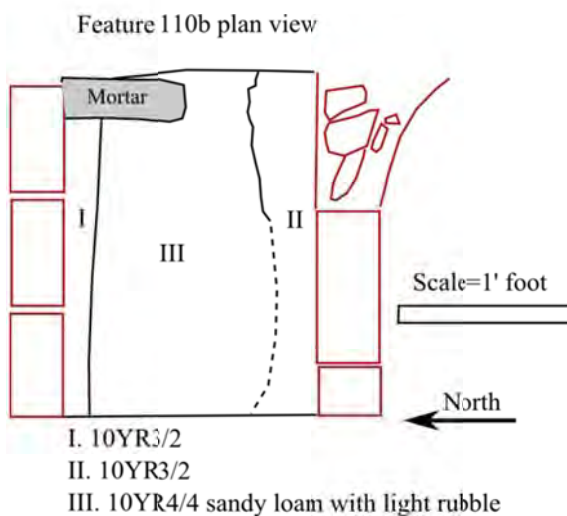
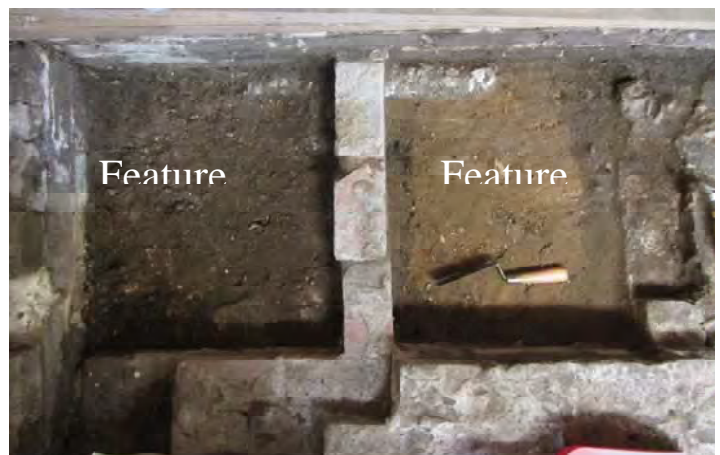
Figure 16: Plan view drawing of feature 110b and plan view photo of feature 110a and 110b

Excavations in Feature 110 proved to be important but also extremely confusing. Each “box” of the feature was excavated separately. The south box, Feature 110b, was excavated first and quickly revealed the two builder’s trenches for both the central, single-course brick “wall” and the more substantial curved foundation wall for the circular brick feature to its south. These builder’s trenches were excavated separately for maximum control. This box was bisected along a north/south access and the west half was excavated; the same was done for Feature 110a to the north. Figure 16 displays a plan view drawing of 110b and a plan view photo of Feature 110a and 110b. Figure 17 displays an east profile drawing and photo of Feature 110b. The feature fill between these builder’s trenches was a 10YR4/4 loamy sand. After 0.4 feet of excavation in this box the builder’s trenches for both north and south brick walls disappeared. The northern one terminated into the next major soil change and did not continue, although the wall did continue for two more courses of brick and a brick footer was found at the bottom. The southern builder’s trench faded away after 0.5 feet, but again, the wall continued (refer to Figure 18). Below the top level of 110a lies a very dense mortar fill with a slight amount of 10YR5/4 sandy silt included in it. This terminated into an extremely dense packed mortar surface, similar to that seen at the opening of the brick circular feature. Isenbarger identified this mortar surface in Unit 1 at the base of her excavations there, and suspected it had something to do with water or air going in or out of the circular feature.

The north box, Feature 110a, was excavated as a single provenience due to the extremely dense rubble fill that never changed the further down into the box we dug. It is a 10YR5/4 and 10YR4/2 loose loamy sand that is slightly intermixed into the rubble, some of which is whole or half bricks. Figure 18 displays an east profile drawing and photograph of 110a. Numerous air pockets were encountered during excavation. Again, a dense mortar bed was encountered at the base. Attempts to push a chaining pin and trowel into this surface proved unsuccessful. The mortar’s purpose is unknown.

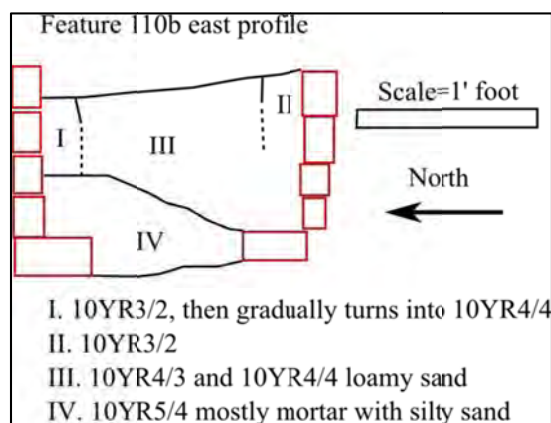
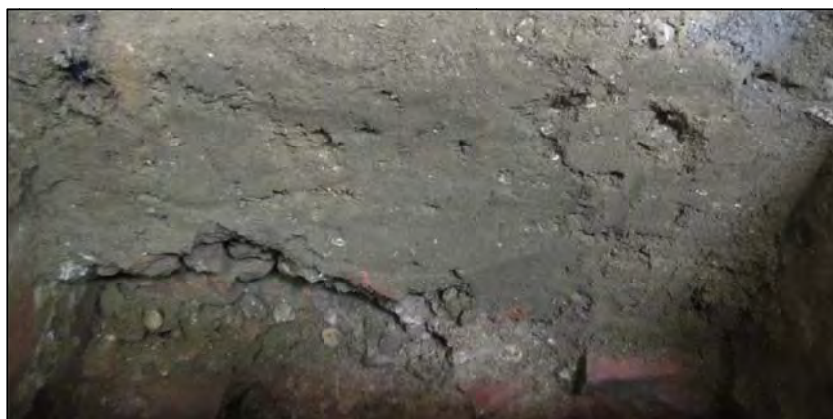
Figure 17: Photo and drawing, profile of feature 110b

There is a cistern outside the laundry room directly north of Feature 110. In the wall above the brick boxes is a brass chute that appears to have delivered water into the room. Did Feature 110 collect that water, or did it go past it and into another receptacle? The puzzling part of Feature 110 is that it was filled with dirt and brick/mortar rubble before the brick partition wall was built down the center of the rectangular space. We have to question if the builder's trench for the center wall was really a builder's trench or was it some other kind of soil deposit that paralleled and abutted against the bricks? Why are Feature 110a and 110b filled with different kinds of fill: one being primarily rubble and the other mostly sandy loam? What function did the mortar bed at the bottom of the feature serve? Or, were these brick chambers supposed to be filled in after they were built? Currently it seems that this feature served some purpose for water but what that purpose was may only be understood through archival work.

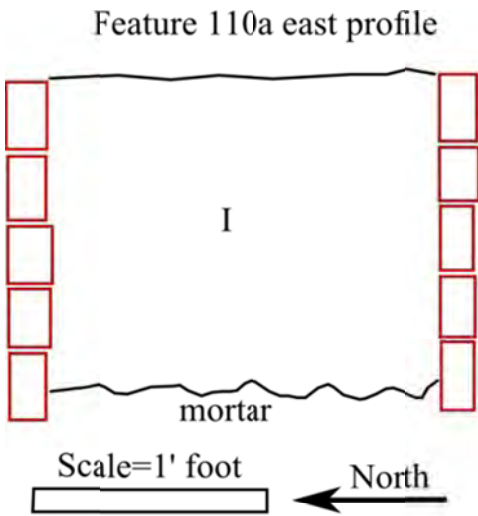
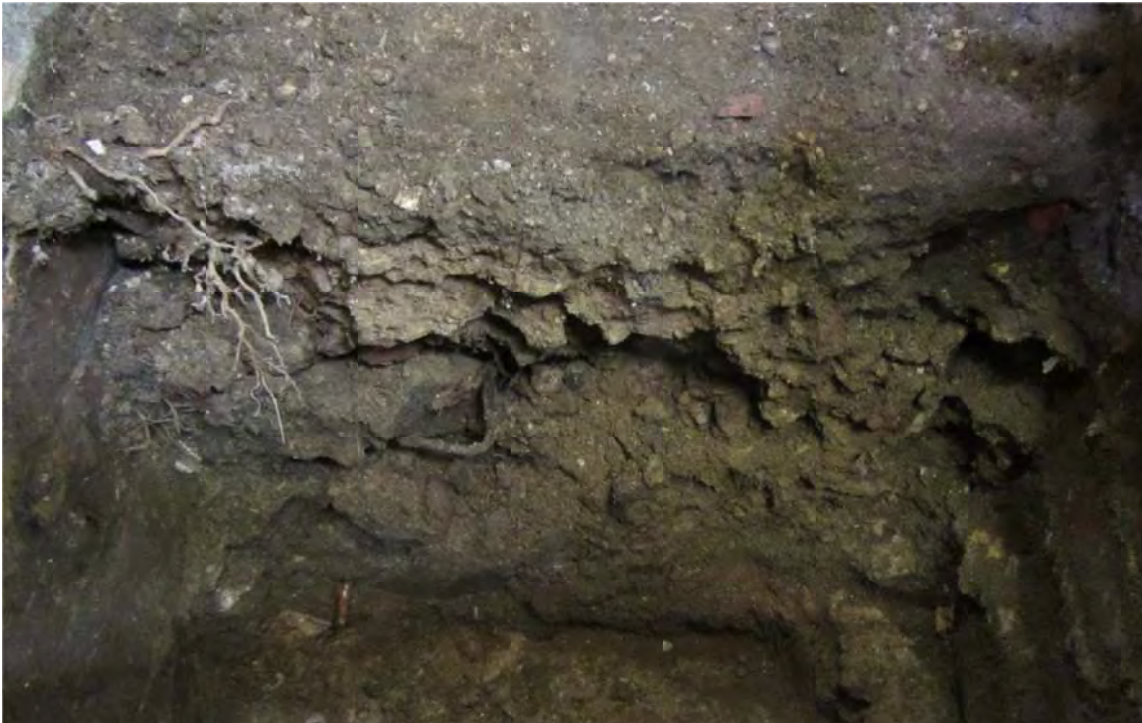
Figure 18: Drawing and photograph, profile of feature 110

I. Heavy brick rubble in a
10YR5/4 and 10YR4/2
loose loamy sand

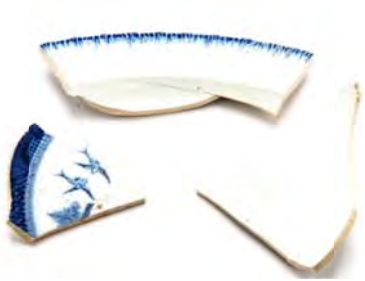
Figure 19: pearlware styles

The blue-tinged refined ceramic known to archaeologists as pearlware was developed in 1780 (Miller and Hunter 2001). The earliest styles feature a molded shell-edged design, painted in blue or green, while the majority of the flatware vessels were undecorated. Hollow ware vessels – bowls, cans, cups – were painted in blue, often in Chinoiserie or floral designs, or in a palette of earthenware colors in a variety of floral sprays, sprigs, and stripes.

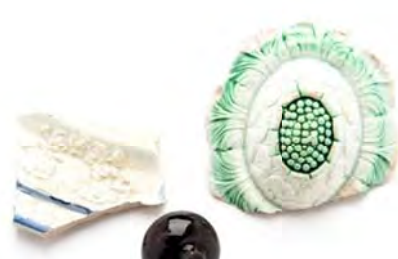
Figure 22: Decorative pearlwares

well as undecorated portions of (likely) shell edged wares. Blue transfer printed wares were the most common. The most distinctive piece was a small handled cup featuring the “Peaceable Kingdom”.

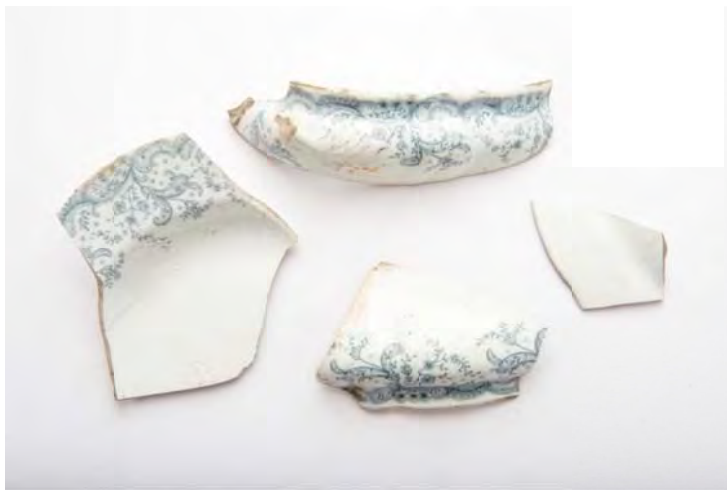
Figure 23: Transfer-printed whiteware by John Maddock & Sons Figure 24: Lustered and printed whitewares

Difficulty in dating whitewares, particularly transfer printed wares, may be reduced when a maker’s mark is intact on a ceramic basal fragment. A distinctive style of grey transfer-printed ware was recovered throughout the laundry deposits, and elsewhere on the Aiken lot in earlier digs. The set is marked “John Maddock & Sons. England. Royal Vitreous.” This particular mark is dated 1880 to 1896 (Godden 1964). Recovered vessels include plates, cups, and a distinctive tureen with a pedestaled base and rounded shoulders, decorated in gold along the rim and handles. Fragments of this ware were recovered in zones 2, 3, and 4.

Luster-decorated wares were developed in the 1840s. Copper or platinum salts produced a metallic glaze in gold or silver, and this was applied to earthenware or whiteware. Lustered wares were produced by C.J. Mason and company, among others. A few fragments of luster ware were recovered in the laundry.

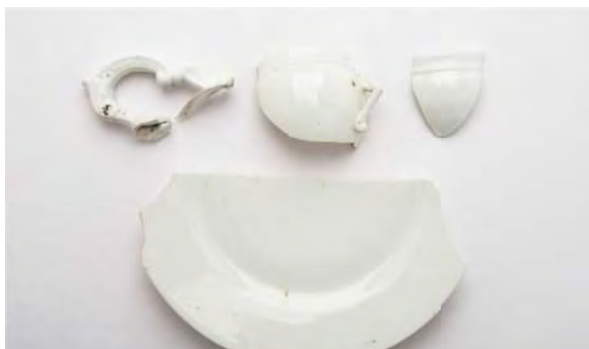
Figure 25: White American porcelain

Far more common is the undecorated white porcelain manufactured and distributed in the United States after 1850. These wares dominate ceramic assemblages in the second half of the 19th century and are an important dating tool. These all-white dishes served as everyday wares; after 1880 they were often trimmed in gold. White porcelain comes in a variety of tableware forms, including plates and hollow wares, as well as decorative forms such as vases and dishes. The upper zones contained several examples of soft-paste e porcelain.

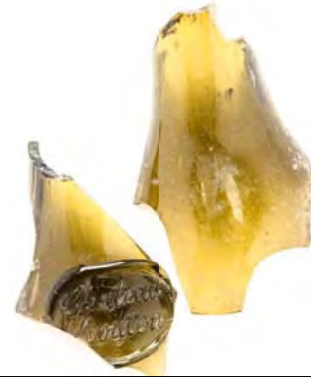
Figure 28: Wine bottle with “Chateau Mouton” seal

Olive green glass bottles often held wine or liquor. The hand-blown bottles typical of the 18th century were gradually replaced by mold-blown bottles, and those from the 19th century are also known as “black glass.” A few large fragments of wine bottle bases came from the laundry. The most distinctive was a wine bottle neck with an applied seal reading “Chateau Mouton.” Despite extensive research, this particular seal could not be identified with temporal certainty. The wine estate of Chateau Mouton Rothschild is located in Pauillac, a village north of Bordeaux, famous for its wines. The initial name of the label was Chateau Brane-Mouton. In 1853 Nathaniel de Rothschild renamed the wine and called it Chateau Mouton, as appears on the Aiken-Rhett seal. At the time, the estate was one of the first to have its wine bottled. The winery remains famous for its high quality wines (www.history1700s.com/index.php/articles/14-guest-authors/970-theadornig-history-of-chateau-mouton-rothschild-label.html).

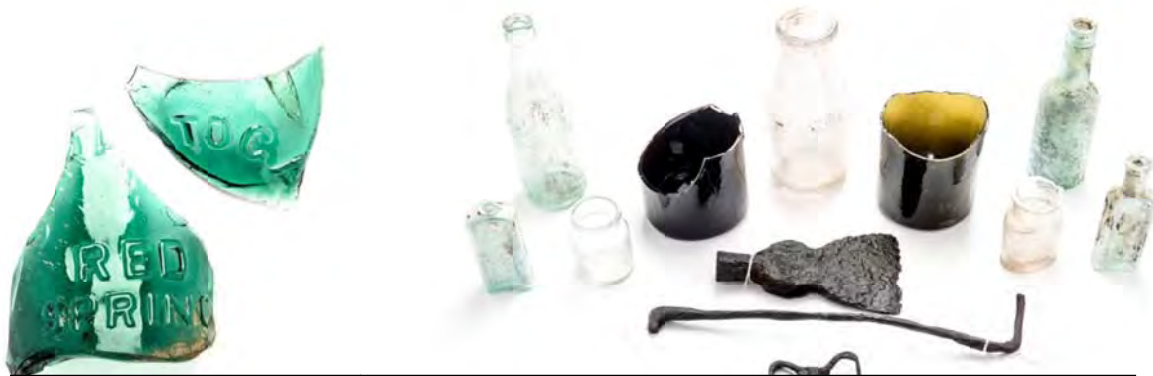
Figure 29: “Red Spring” water bottle

Brown glass containers often held liquors or beers. The Aiken-Rhett assemblage included smaller pint flasks and rounded beer bottles. The latter were principally from the 20th century, and featured crown cap necks. Blue bottle glass is most often associated with mineral or soda water, which became popular by the mid-19th century and common in the third quarter of the century. Soda water bottles were also made in clear and green glass; they are squat, heavy bottles with a thick rounded lip. The Aiken-Rhett laundry features a bottle from a more unusual source. Several fragments of a distinctive emerald green bottle were recovered, marked “Red Spring” and “toga”, for Saratoga. The bottle dates to the 1870s, based on similar examples. Saratoga,

Figure 30: Various bottles, including those for beverages, sauces, and pharmaceuticals

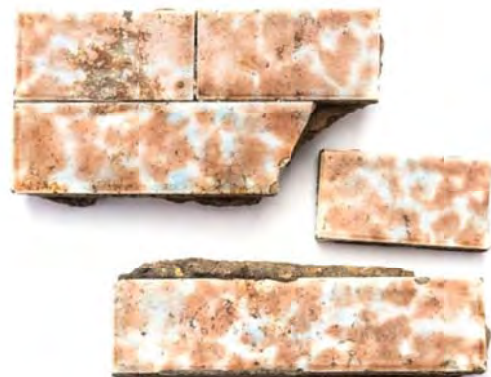
Figure 33: Encaustic tiles

Two types of tile were discovered. The first is a fragment of blue-painted delft tile. Delft tiles surrounded the fireplaces of homes in Charleston throughout the 18th century. On the opposite end of the temporal scale are encaustic tiles with a glazed surface. The tiles are mottled brown with light blue

areas. No such tiles are extant in the house or outbuildings, though similar tiles with a green glaze were added to the front parlor in the 1890s.

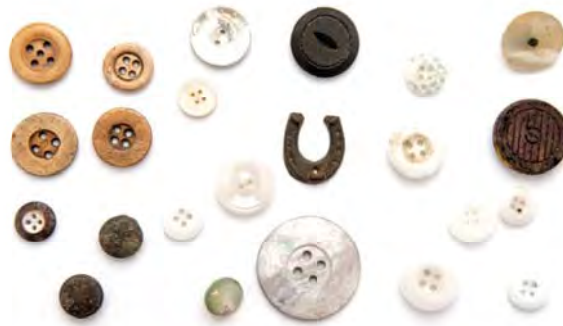
Figure 35: Buttons from the Aiken-Rhett laundry; bone, prosser, shell, hard rubber, glass

A few examples of buttons developed in the second half of the 19th century were recovered. Black glass buttons, in imitation of jet, became popular following Queen Victoria's use of jet buttons after the death of Prince Albert in 1861 (Epstein 1968). Her mourning made such black garments fashionable, and the demand for jet created the market for black glass imitations, which were often carved, molded, or otherwise decorated. A single example was recovered at Aiken-Rhett. Two large iron buttons with a fiber center came from zone 3. Finally, hard rubber buttons were developed by the Goodyear company and patented in 1851 (Miller et al. 2000:16).

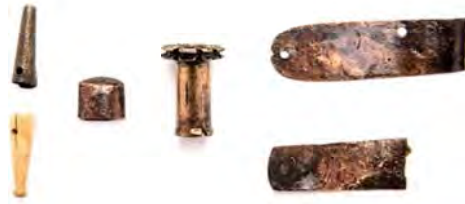
Figure 38: Parasol hardware; pocket knife sections

Items of personal possession ranged from .7% to .3% of the site assemblage. This group includes a range of items, commonly kept by individuals. Slate pencils (11) for use with writing slates were scattered throughout the deposits. There were four bits of parasol or umbrella hardware, including the central brass slide and brass or bone tips to the ribs, and a pocket knife.

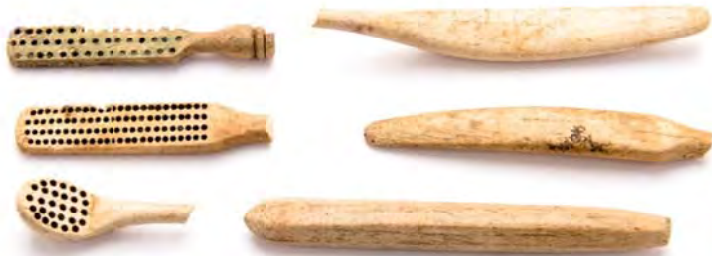
Figure 39: tooth brushes

Bone toothbrushes and hair brushes, both hallmarks of the 19th century, underscore an increasing emphasis on cleanliness and personal hygiene, as does the modernized laundry itself. Tooth brushes were available in America by the late 18th century, and first manufactured in America by the turn of the 19th century. Two-sided, or double-headed tooth brushes were the first type available. By 1840, toothbrushes were produced in large quantity, and some were marked with the manufacturers' names. Particularly

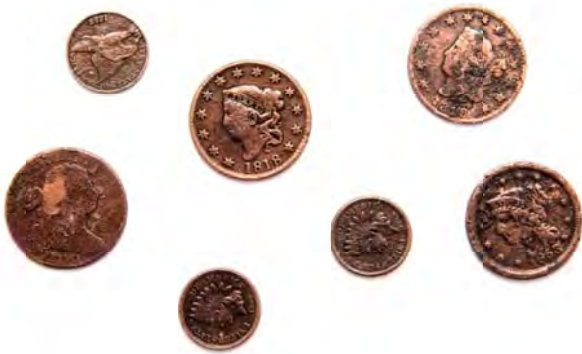
Figure 40: British and American coins

The underlying zone 4 produced five coins, all larger Lady Liberty pennies. The earliest is illegible but is a style known as "classic head" dating between 1811 and 1814. A second dates to 1819. Two "matron head" cents date to 1831 and 1832, while the "braided head" penny dates to 1847. It is interesting to note that the date ranges of the coin assemblages correspond with the dates of deposition proposed from other artifact sources; zone 4 has been associated with Period II, 1833-1857, and all of the coins recovered from zone 4 predate 1857. The coins from zone 3, associated with Period III, 1858-1876, fall closer to that time period, with coins from the 1850s and 1860s.

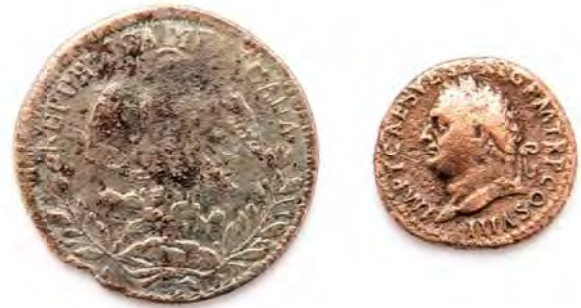
Figure 41: Mexican coin; 1st century Roman coin

The final coin, recovered from the earliest deposit, zone 5, is not associated with the laundry at all, and was not legal tender during the era of laundry operation. It is a Roman coin from the first century a.d. It was identified by Holly Adington, an intern working on the Aiken Rhett analysis and a classics/anthropology major at the College of Charleston. The coin shows “Titus as Augustus” or Sestertius, and dates to 80 a.d. This is more likely an item that the Aikens acquired on their grand tour, or was in their possession as a curiosity or antiquity.

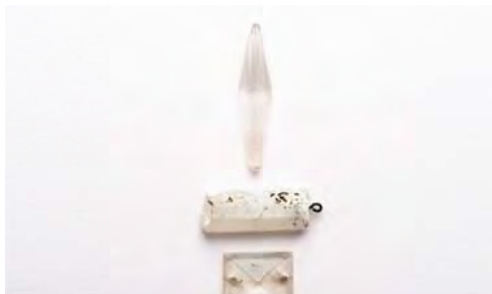
Figure 42: Chandelier prisms

Artifacts from furniture comprised less than 1% of the assemblage. The most common furniture items were brass upholstery tacks, an artifact whose form remained unchanged from the 18th through 20th centuries. Three chandelier prisms, similar to those remaining on fixtures in the house, came from the laundry soils. Others of this type were recovered from units near the laundry. Furniture hardware included brass curtain rings and a large decorative drawer pull medallion.

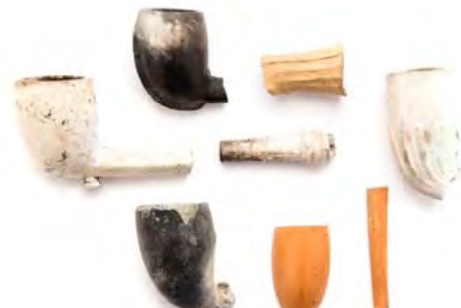
Figure 44: Kaolin and red clay tobacco pipes

Tobacco pipes ranged from .3 to 1.5% of the temporal assemblages. These included white ball clay stem fragments and larger fragments of pipe bowls. Some fragments of red clay pipes and glazed stub-stemmed

pipes were recovered as well. The decorative stub-stemmed pipes are hallmarks of the 19th century.

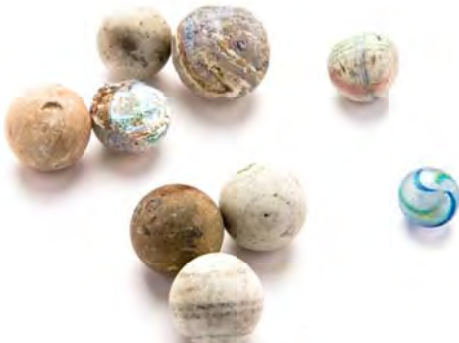
Figure 45: Clay, china, and glass marbles

Lost, or discarded, children’s toys were found throughout the laundry. Marbles were the most common. The Aiken-Rhett assemblage ranged from plain grey and white clay to the more unusual stone marbles. German “chinas” or white clay marbles were imported to the United States in large numbers between 1840 and 1910. They are plain, or painted with wide or narrow lines, leaves, and pinwheels (Garskadden and Gartley 1990). Cane-cut, or latticino glass marbles were developed in Germany in the 1880s and produced until World War I (Block 1978; Barrett 1994). Solid colored glass marbles were also available by the late 19th to early 20th centuries.
